Manhole Inspection Summary

Manhole # S07SS1003MH

Insp Date: **9/27/06 7:21 AM**

Location Address: **3315 W ROGERS AVE**

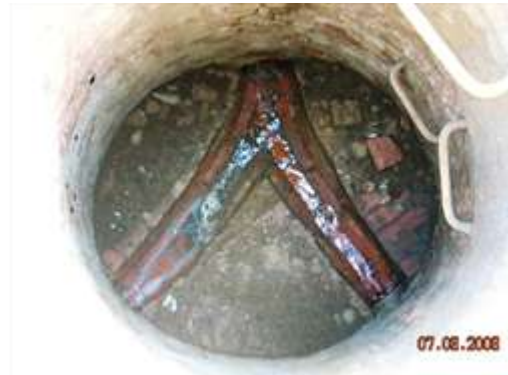
Top View

☒ **Evidence Of Surcharge**

Depth: **1.5** (ft.)

Evidence of surcharge - Bench debris.
Channel debris.

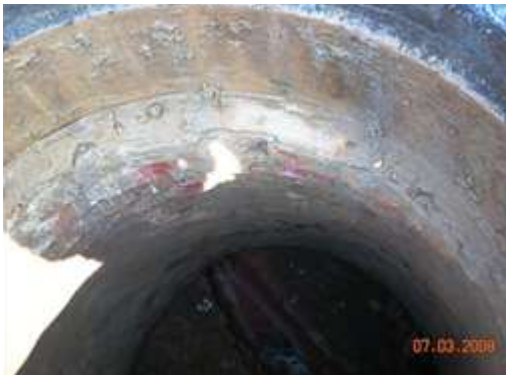
Defect

☒ **Leaks**

Infiltration: ☐ None ☒ **Joint** ☐ Cracks ☐ Mortar ☐ Roots ☒ **Wall**

Infiltration: ☐ None ☐ Joint ☐ Cracks ☒ **Mortar** ☐ Roots ☒ **Wall**

Frame leaks. Adjustment and Barrel
infiltration.

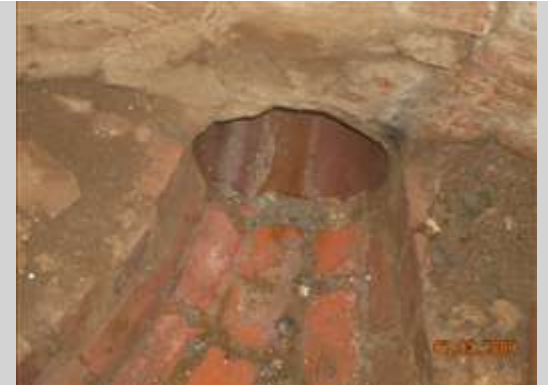
8 in. Circular Gravity Sewer Pipe Out @ 12 O'Clock

Infiltration: **Evidence** Pipe Seal Cond: **Unknown**

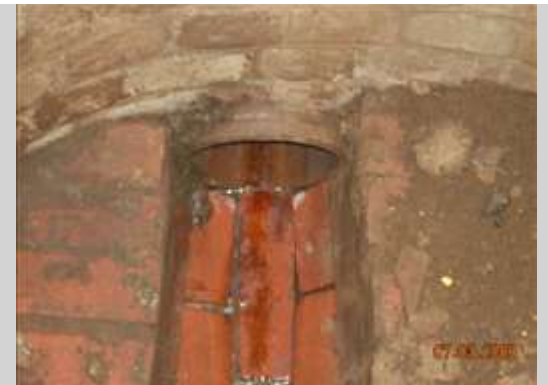
6 in. Circular Gravity Sewer Pipe In @ 5 O'Clock

Infiltration: **Evidence** Pipe Seal Cond: **Unknown**
